Thurston Pond

Stormwater Repairs Update

July 27, 2021

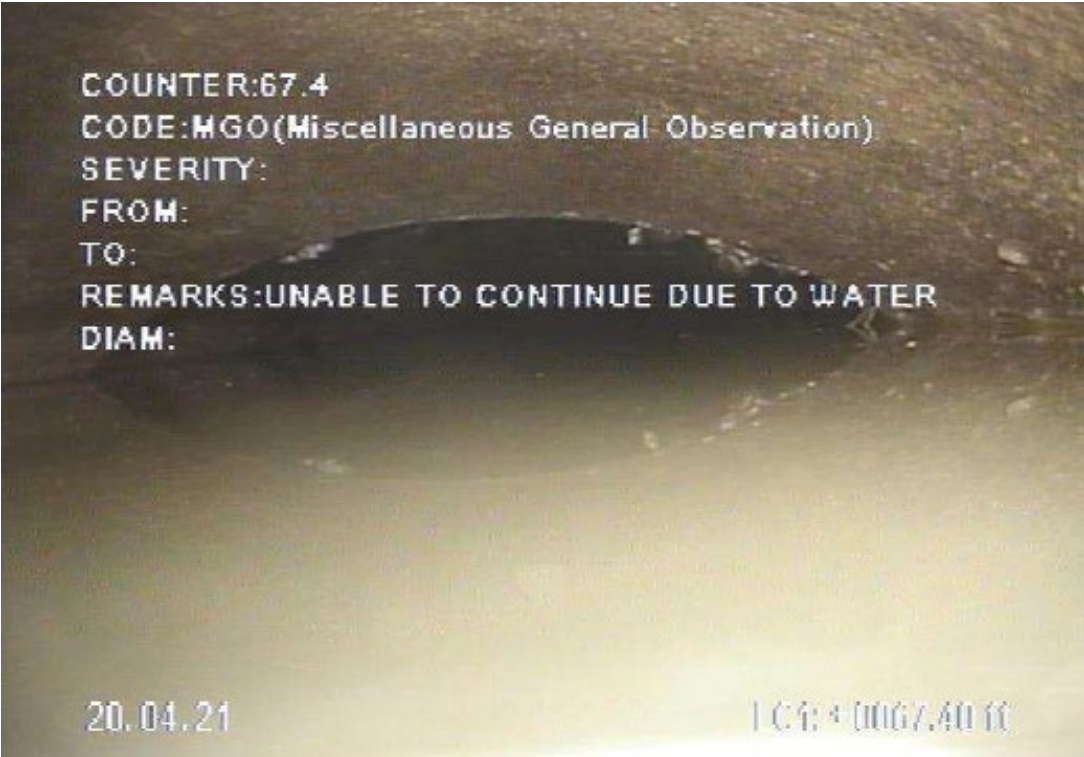
Water Level at 100% at 67'

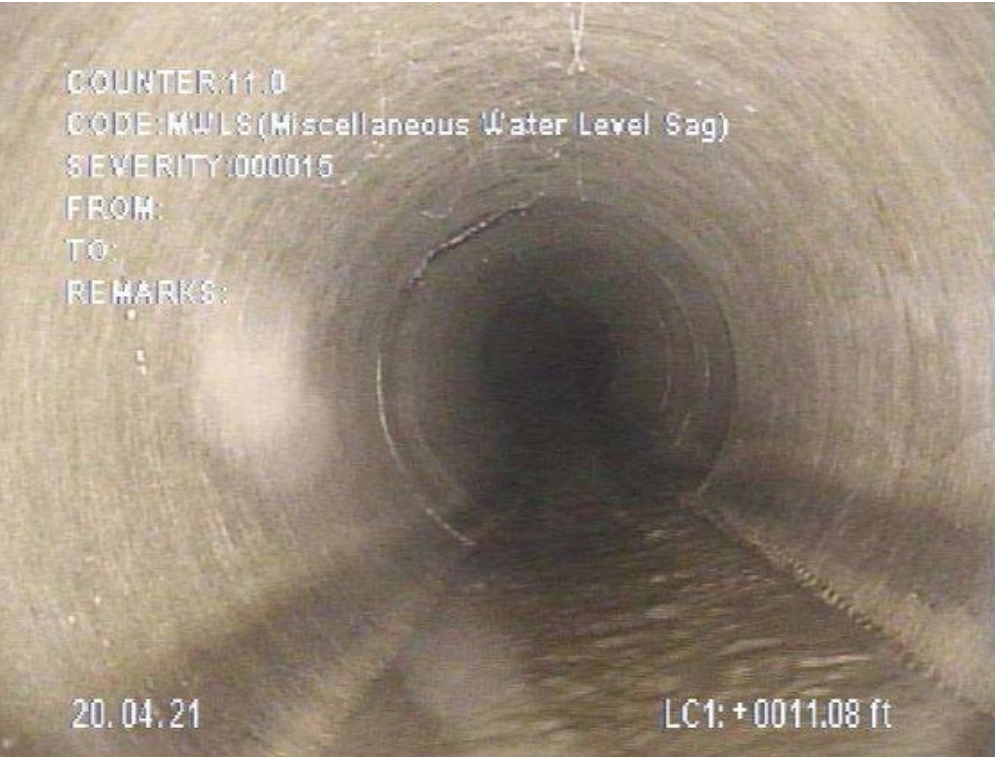
Flow Levels at Downstream End

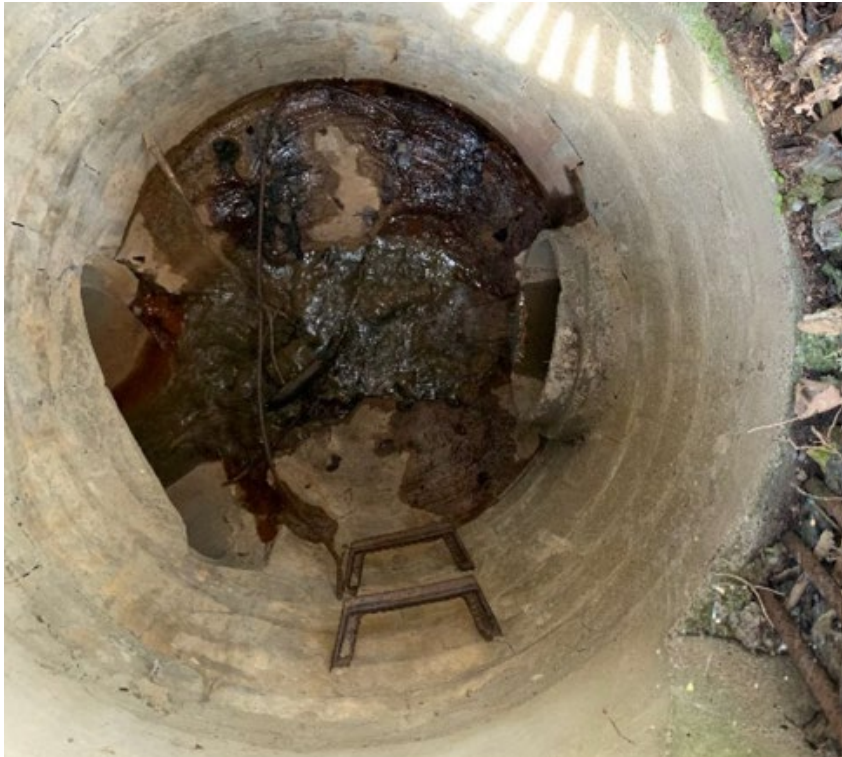
Downstream End of Pipe

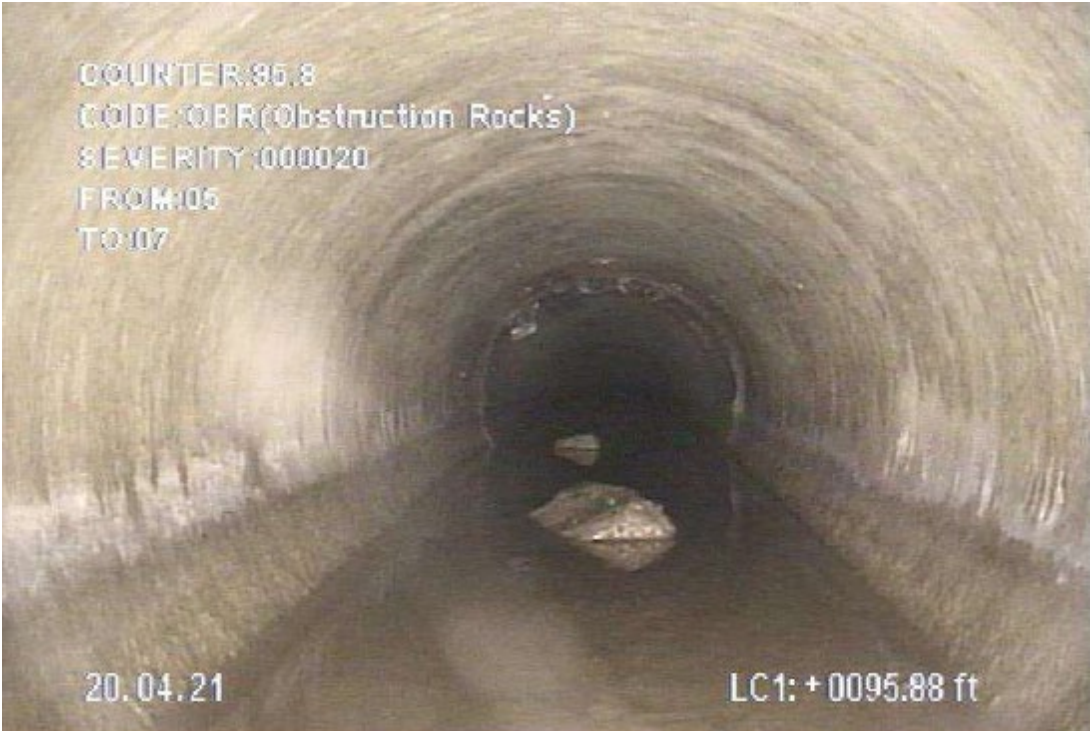
Sand and Gravel Debris in Pipe on Downstream Side

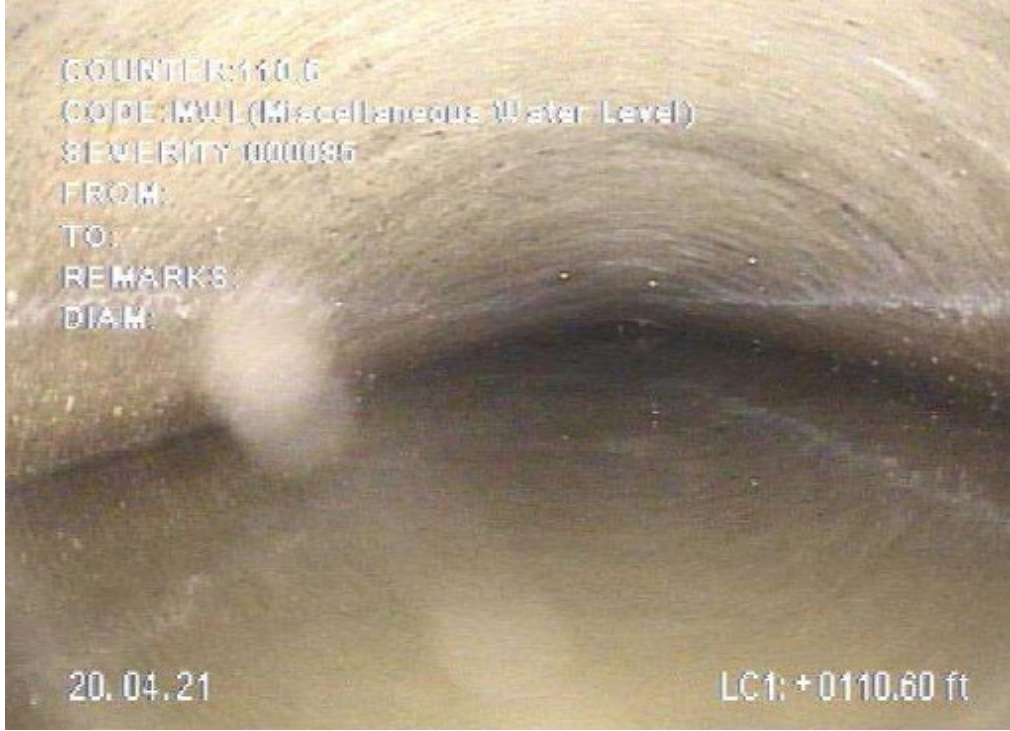
Water Level at 100% at 114'

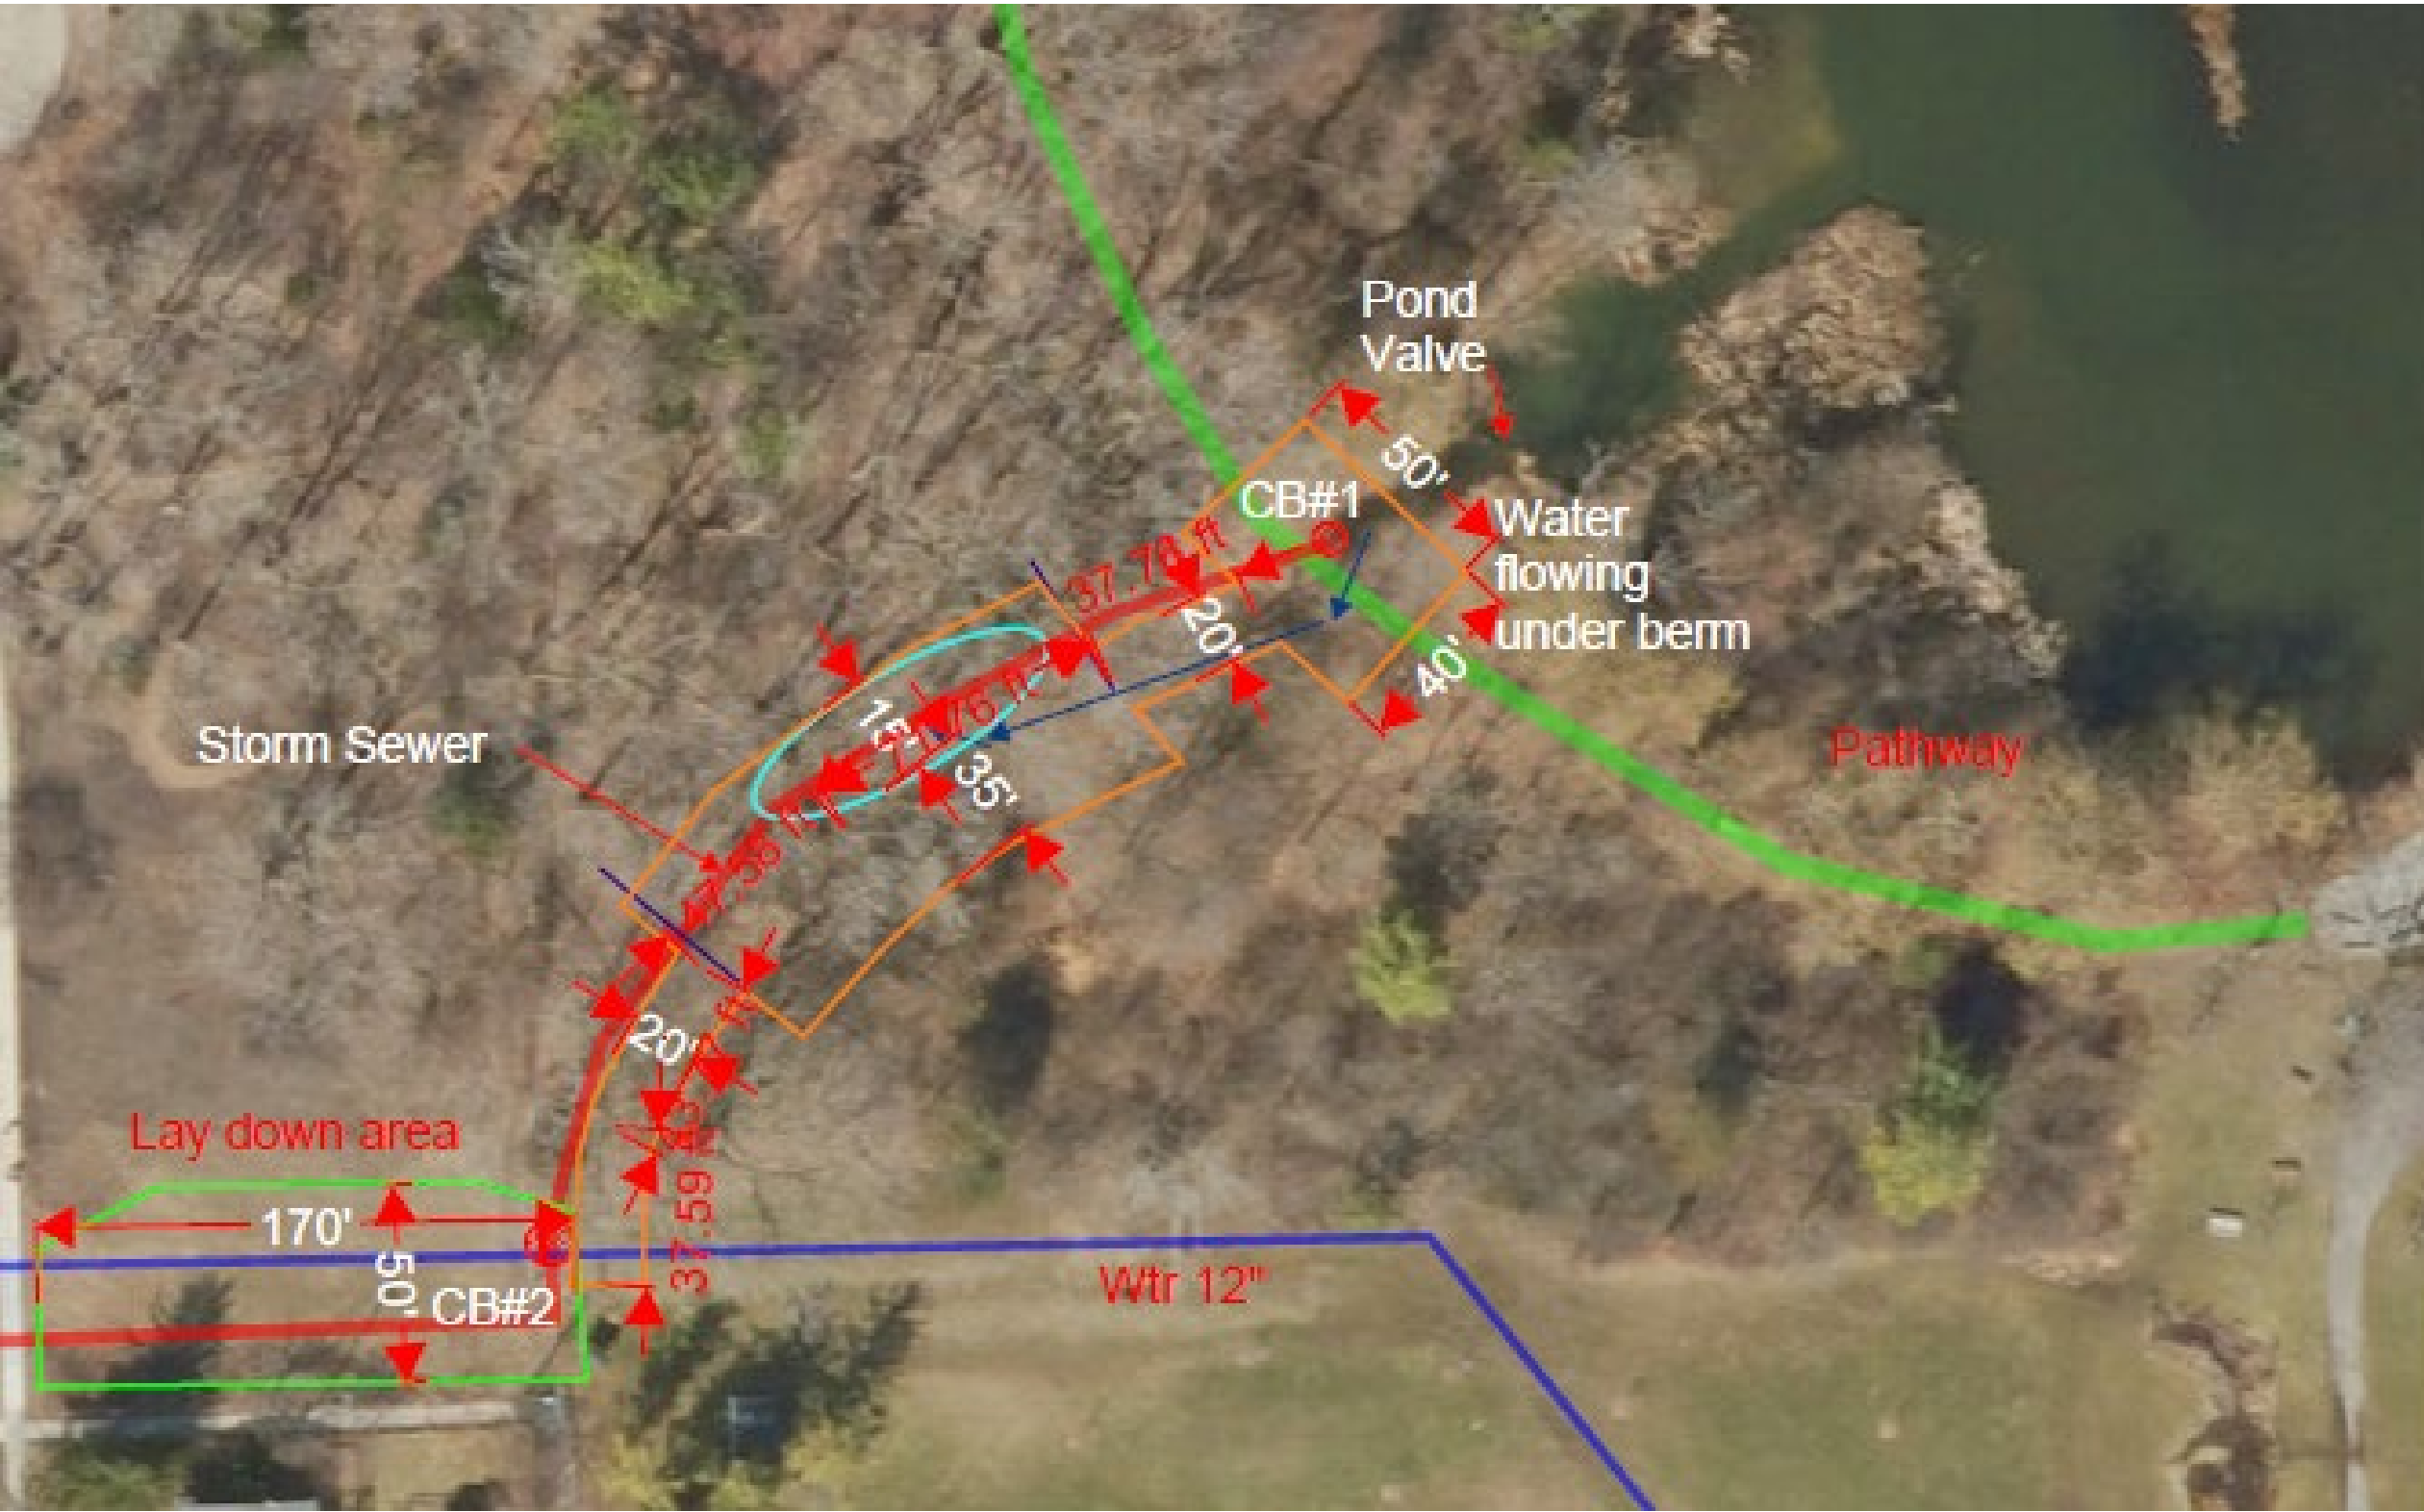
Thurston Pond
Storm Clearing
Aerial View

The storm sewer repair will require the pipe to be exposed with an excavation approximately 10’ deep and 40’ long.

In order to effectively and safely make the repair, the pond level will need to be lowered to minimize the presence of water during the repair.
