# Restoration of the Thurston Pond Ecosystem

July 12, 2013 revision of the February 2005 Thurston Pond Restoration Plan.

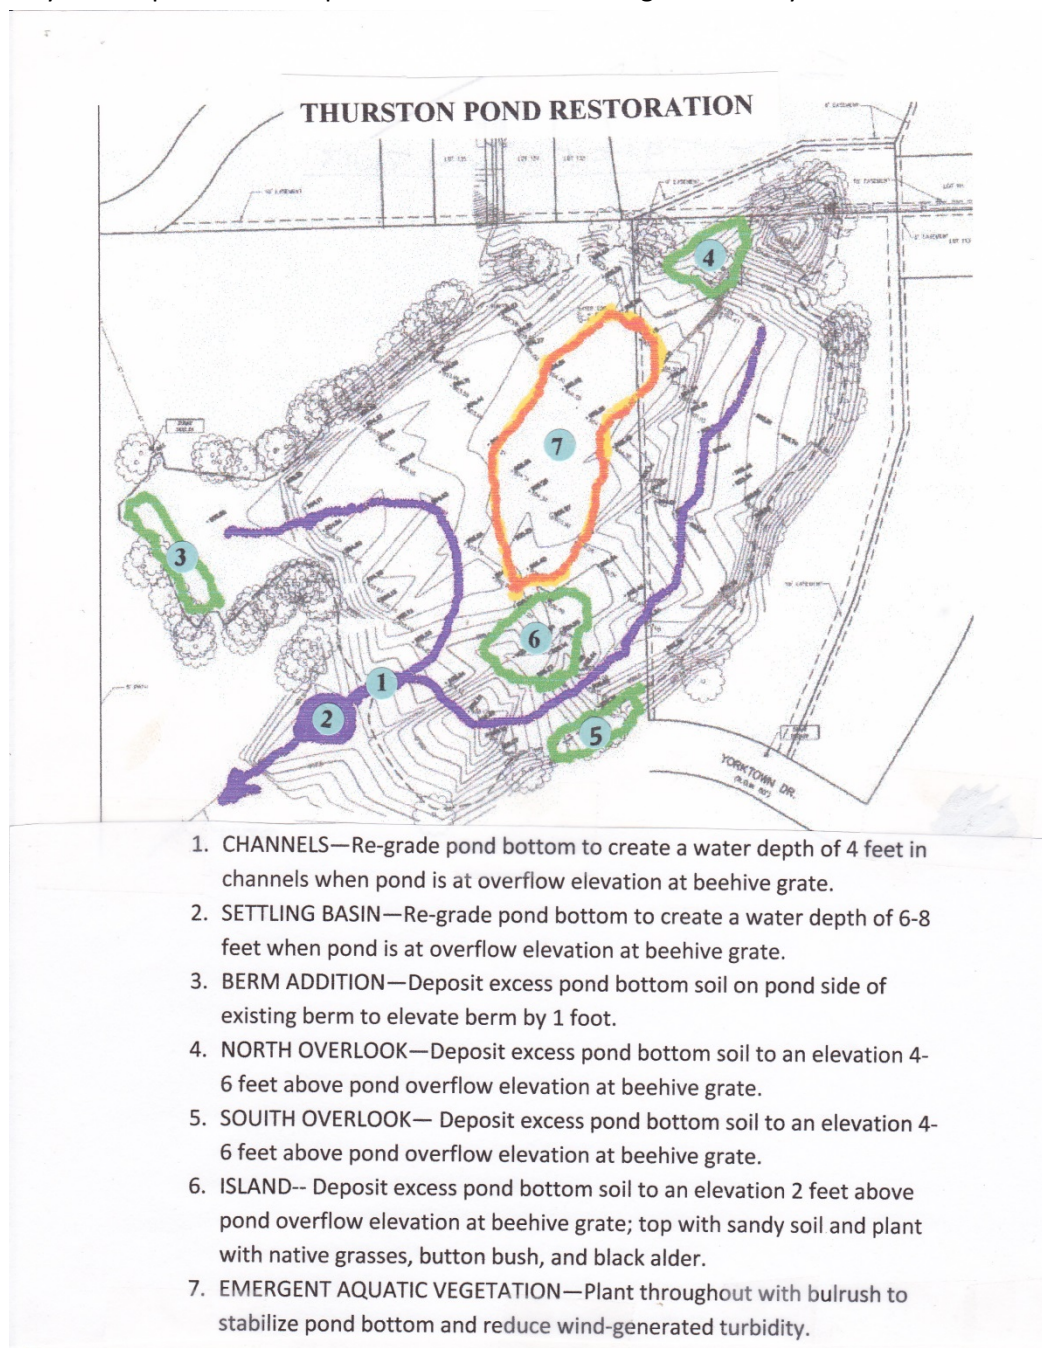
A minimum re-grading effort that would provide more deep-water habitat and allow the pond to be fully drained is shown in Figure 5. The proposed channel extending from the northeast corner of the pond to the pond outlet on the southwest corner of the pond would allow gravity flow of water from the deepest portion of the pond to the pond outlet. A second channel leading from the berm area on the northwest side of the pond to the outlet would help ensure connectivity of that portion of the pond with the outlet during low water years.

**Figure 5: Thurston Pond re-grading plan endorsed by the TNCC.**

For the outlet system to function properly a 6 to 8-foot deep settling basin (Area 2 in Figure 5) will need to be created in the pond at the mouth of the outlet channel or culvert. This will trap migrating soft sediment and prevent its discharge into the storm water system and Millers Creek. Sediment accumulating in the basin can be periodically pumped into adjacent wooded areas or elsewhere on site where it can be used constructively.

**5.3.** Re-grade the pond bottom in late spring-early summer. Use the excess soil to elevate the existing island, elevate and widen the berm at the west end of the pond, and create pond overlooks as shown in Figure 5.

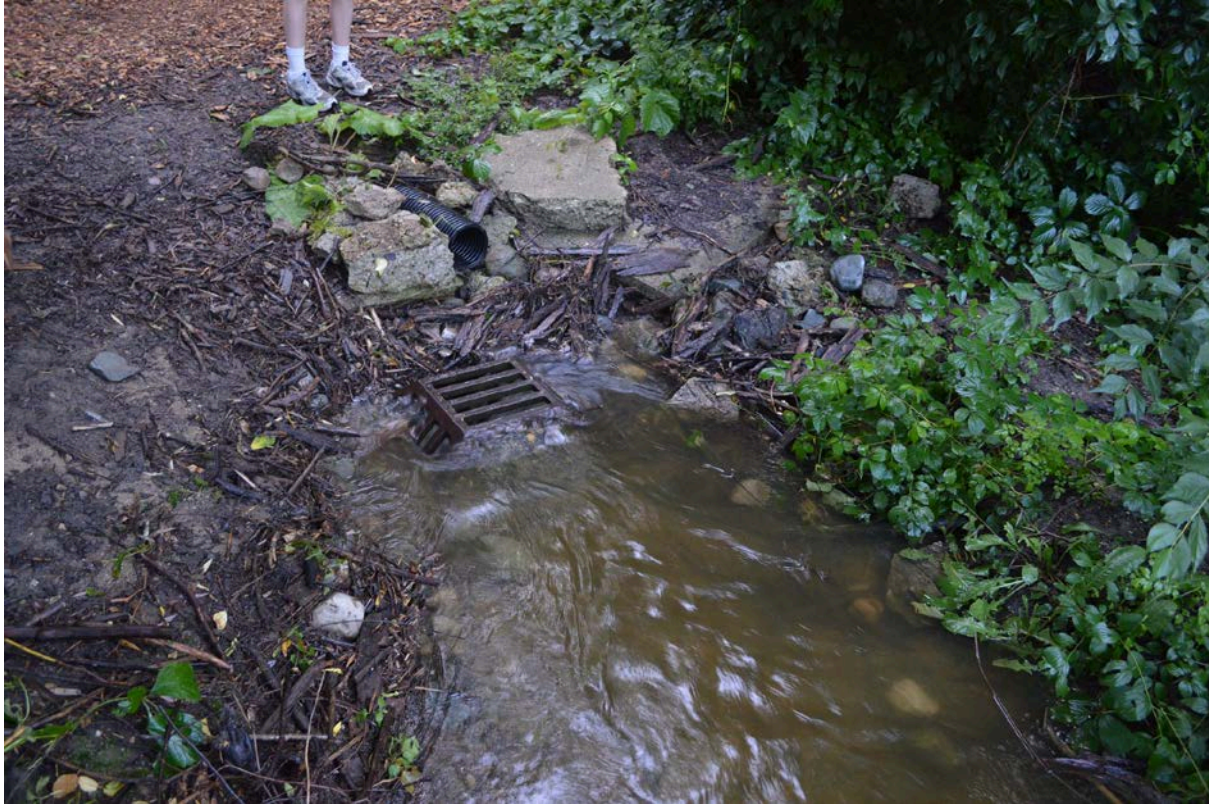
The existing Thurston Pond outlet consists of a beehive grate (Figure 6 )through which the pond water overflows into the underground Prairie Street storm water system that discharges into Miller Creek at Plymouth Road. Note that the

current emergency outlet (black corrugated plastic pipe visible between two broken blocks of concrete) is about 1 foot in elevation above the beehive grate. TNCC observations in June 2013 revealed that the pond level was within about 3 inches of overflowing the berm when the high water flow shown in Figure 6 was recorded. Thus, the emergency overflow is non-functional.

**Figure 6: Existing Thurston Pond outlet at the beehive grate.**

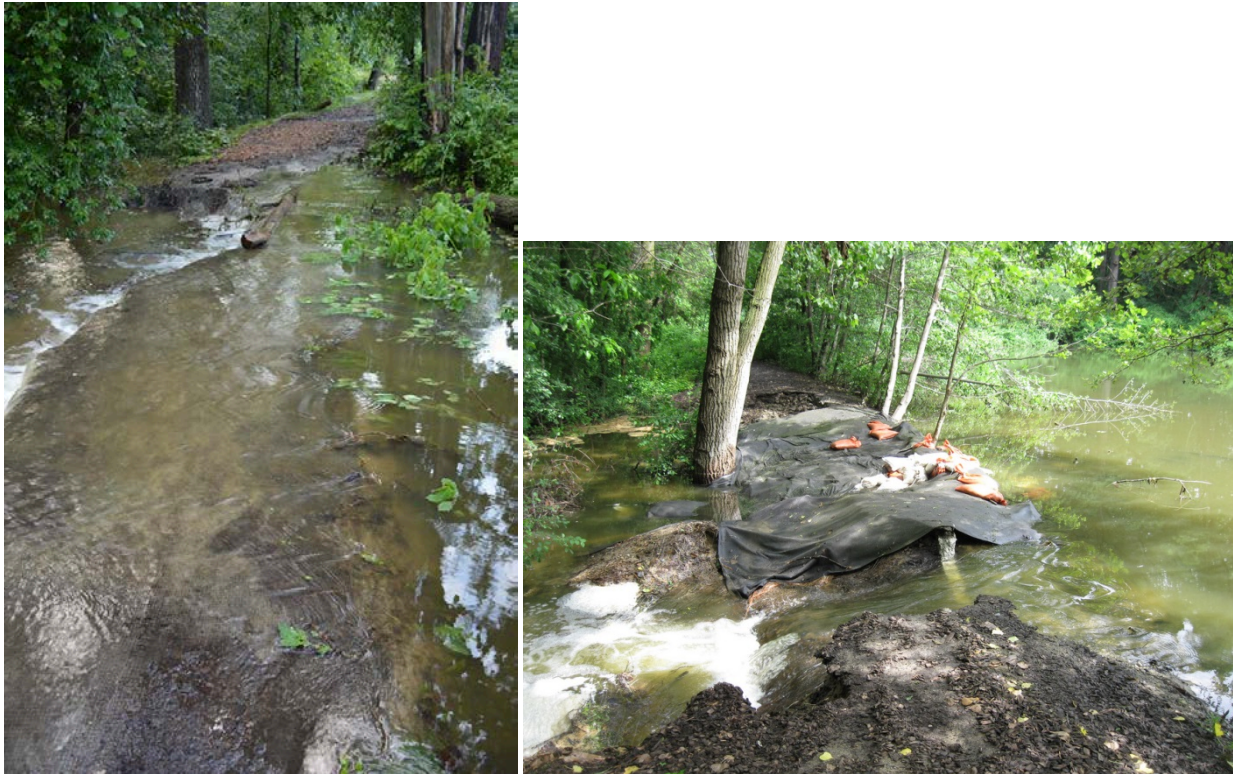
**Figure 7: Berm overflow and erosion during high rainfall events in 2010 and 2013.**

There is continuing danger of berm erosion unless pond re-grading and outlet modifications proposed in this document are undertaken to better handle major storm water event flows that are becoming increasingly common.

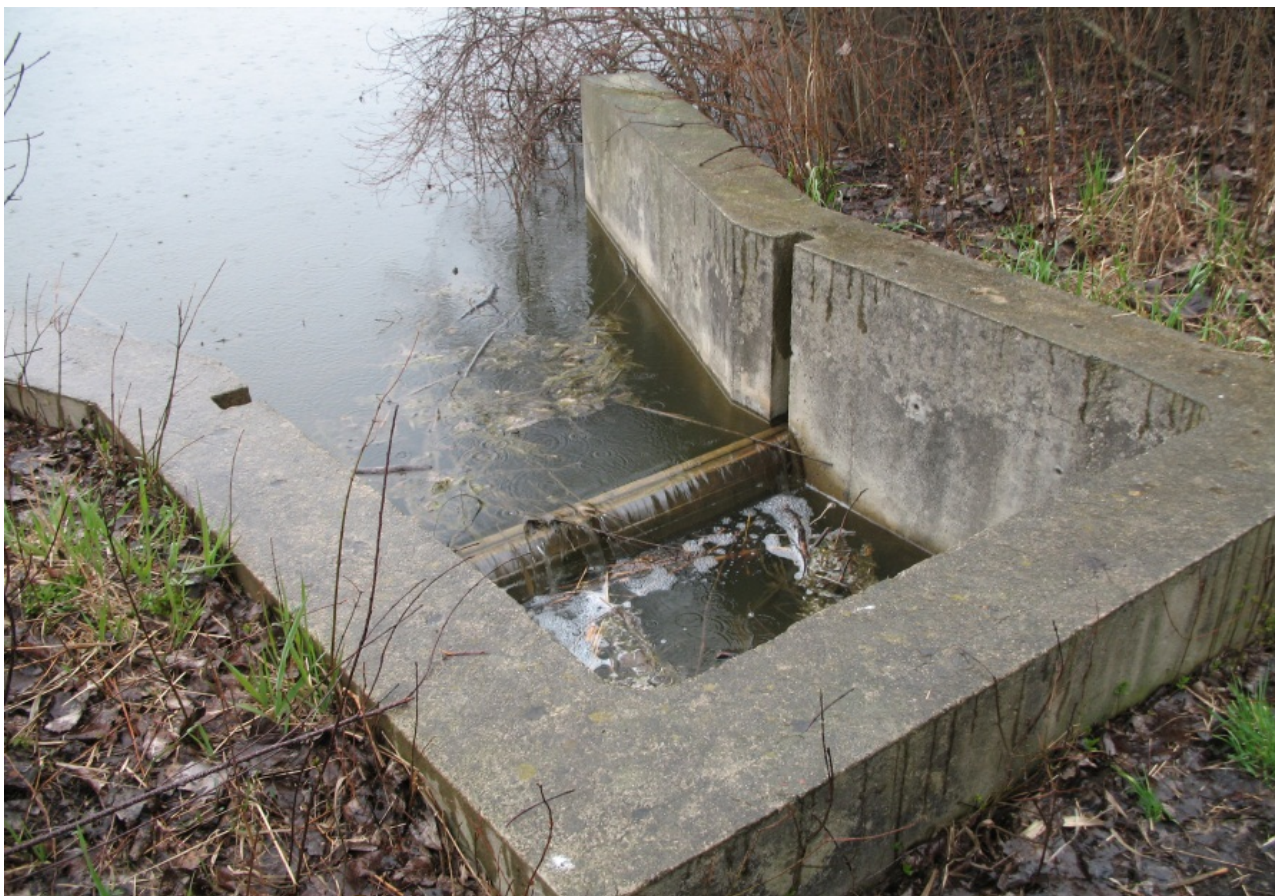
**Figure 8: A proposed new outlet system for Thurston Pond that would enable improved water level and outflow management.**

The TNCC recommends modifying the existing outlet system by replacing the beehive grate structure with a modified stop-log structure similar to the one shown in Figure 8. In the modified stop-log structure, the wall in the foreground would be lowered and connected to a concrete overflow apron several feet wide, with sloping sides, and crossing the berm. Under high-water emergency conditions when the existing storm-water system downstream from the stop-log structure could not carry all of the pond outflow, the overflow apron would allow the excess water to spill over the berm and into the woods on the west side of the pond. The overflow apron would be constructed to allow it to serve as an easily crossed surface feature in the walking trail on the berm. The elevation of the bottom of the channel of the overflow apron would be 1.0 feet lower than the elevation of the lowest crest elsewhere on the pond berm.

Outflow from the pond to the stop-log structure would be carried by an open, 4-foot deep channel cut through the cattail wetland, or by a large diameter concrete culvert buried beneath the wetland. The bottom of the channel or culvert would need to be 4 feet below the elevation of the existing beehive grate to allow the pond is to be drained for pond deepening and removal of phosphorus-laden sediment that is causing eutrophication and preventing restoration of the clear-water condition—the project’s major restoration goal. It could also help with control of invasive wetland plants such as *Phragmites*.

If a buried culvert is used as the primary outlet channel from the pond to the stop-log structure, the excess flow under high-water emergency conditions would run on the surface through the cattail wetland to the stop-log structure and then into the woods via the overflow apron.

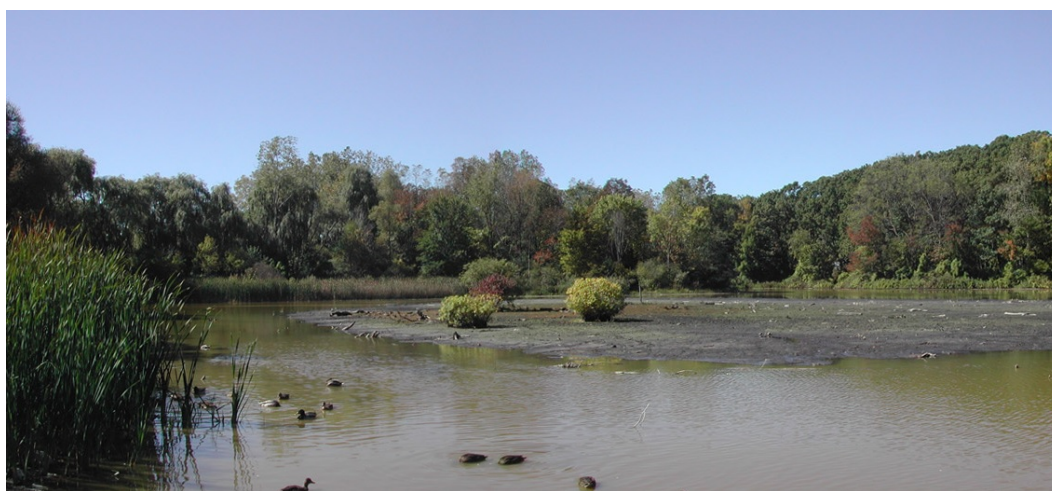
Figure 9: The existing island in Thurston Pond.

Use a portion of the excess pond-bottom soil created by re-grading to increase the elevation of the existing island (Figure 9) about 2 feet. Cap the island with loose sandy soil to provide nesting habitat for turtles.
